### C. Structural Frame

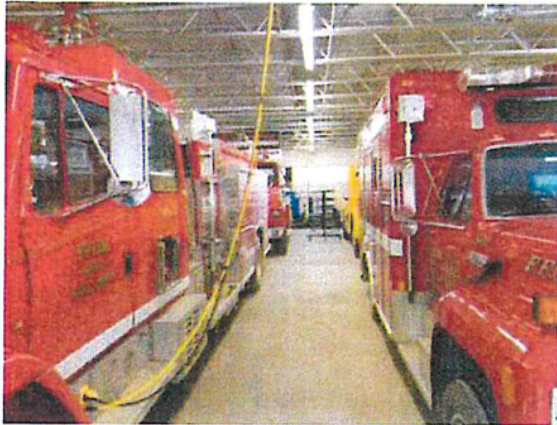
Figure C.2.1

1. Foundation
  1. The foundation appears to be in good condition as there is no evidence of building settlement.
2. Slab-on-grade
  1. Where visible, the slab appears to be in generally good condition.

- (1) There are minor cracks in the apparatus bay floor as is expected where there are no control joints.
    - (2) There is patching of the apparatus bay floor where the original office was removed during the apparatus bay expansion.

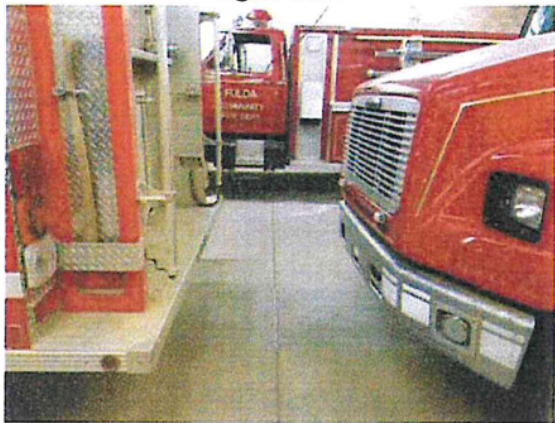
Figure C.2.2

2. The joint between the original Bay floor and the Bay Addition floor is in good condition.
3. Superstructure
  1. The exterior bearing walls are concrete masonry and are generally in good condition.

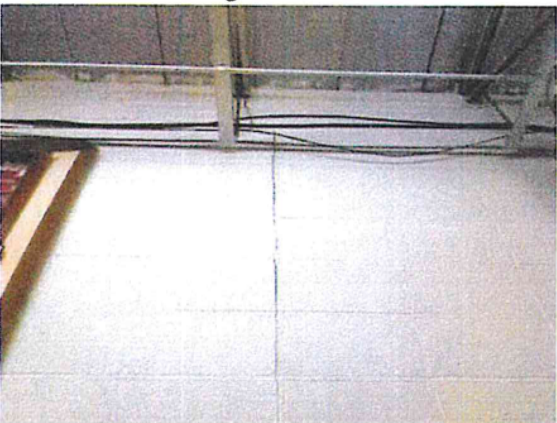
Figure C.3.1.1

- (1) There is continuous vertical cracking at the southeast corner of the Bays.
    - (2) There is continuous vertical cracking at the east side of the Bays.

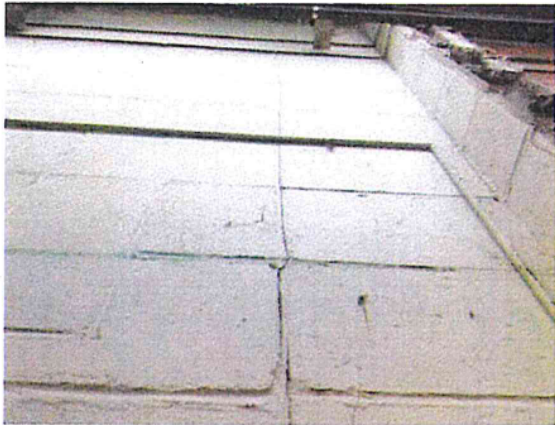
Figure C.3.2.1

2. The interior bearing walls are concrete masonry and brick-faced concrete masonry at the Bay addition. They are in generally good condition.
    - (1) There is continuous vertical cracking just south of the original north wall of the apparatus bays.

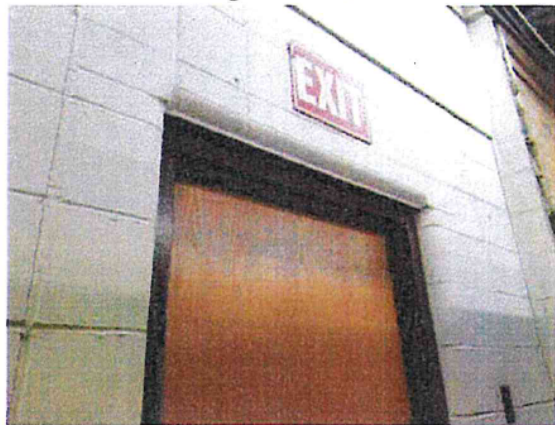
Figure C.3.2.2

- (2) There is continuous vertical cracking just south of the door connecting the Bays with the City Hall lobby.
  3. The original roof structure is cement decking over steel trusses and the 1980's addition roof structure is metal deck over steel trusses. All appears in generally good condition.

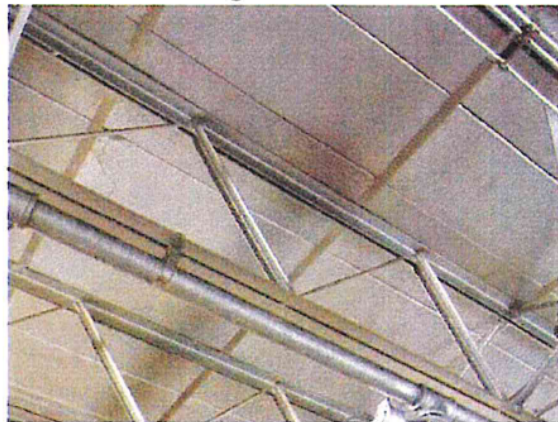
Figure C.3.3.1

- (1) There is minor cracking at some of the cement decking.

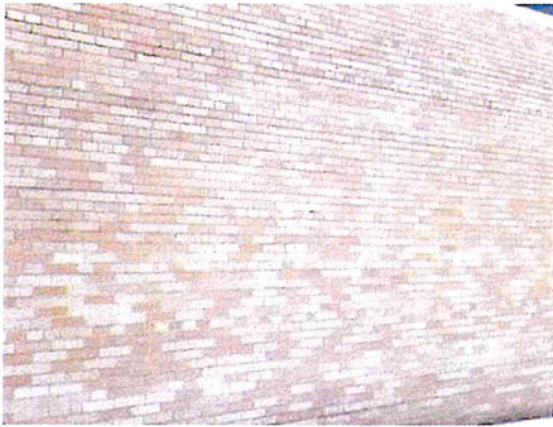
Figure D.1.1

1. The exterior walls are of standard brick and are in generally good condition.
  - (1) There are some locations along the west wall of the boiler room where the mortar has separated from the bricks. This should be tuckpointed.

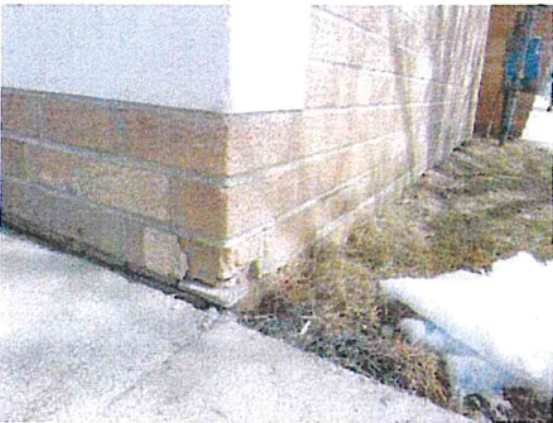
Figure D.1.1.2

- (2) The brick at the southwest corner of the office is spalled.
  - (3) There is no sealant at the base of the wall where it meets a concrete sidewalk.

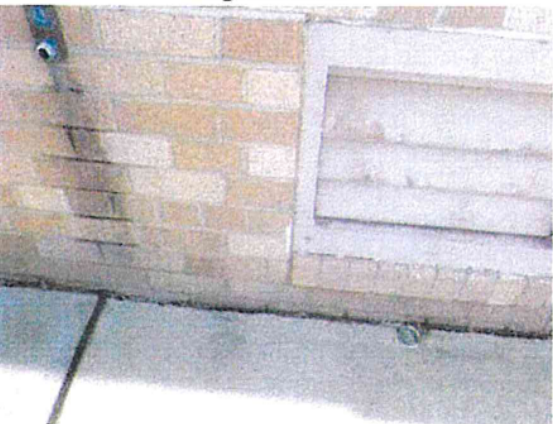
Figure D.1.1.4

- (4) There is no evidence of flashing at the base of the wall. The construction of the wall might be such that the flashing is not required, but it is typically installed as a best practice.

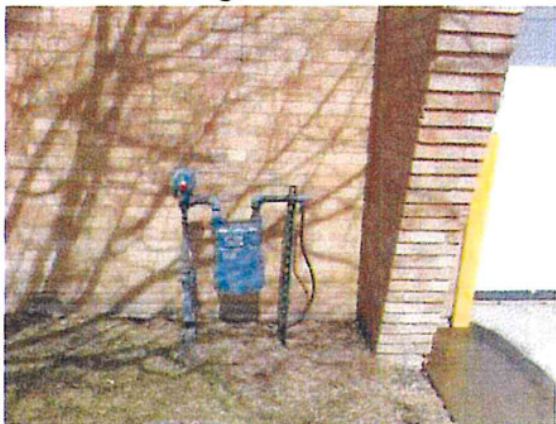
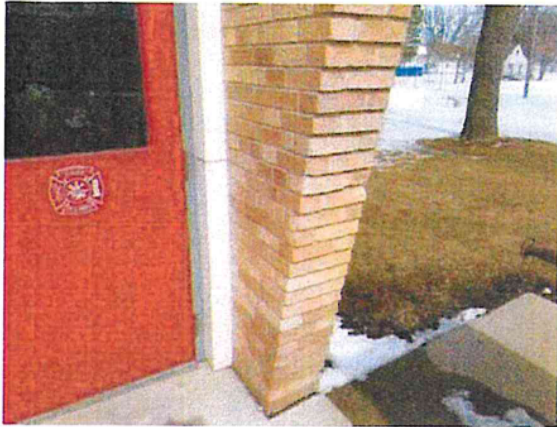
Figure D.1.1.5a

- (5) The corbelled brick at south wall is chipped and spalled in many locations.
  - (6) The brick at the base of the corbelled brick at the southeast corner is missing.

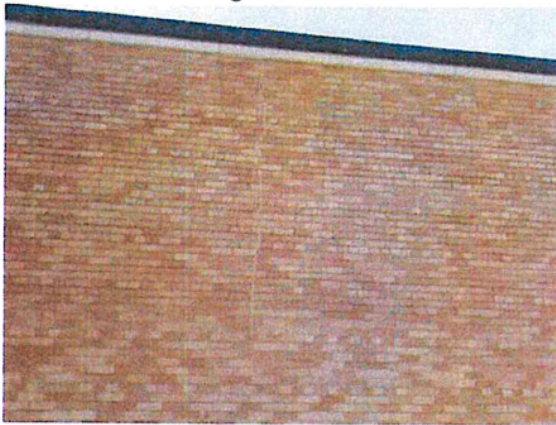
Figure D.1.1.7

- (7) There is a crack at the east wall that has been sealed. We anticipate that sealants will need to be replaced within five years.
  - (8) There are bricks at the northeast corner of the apparatus bays that are cracked or spalled and should be repaired.

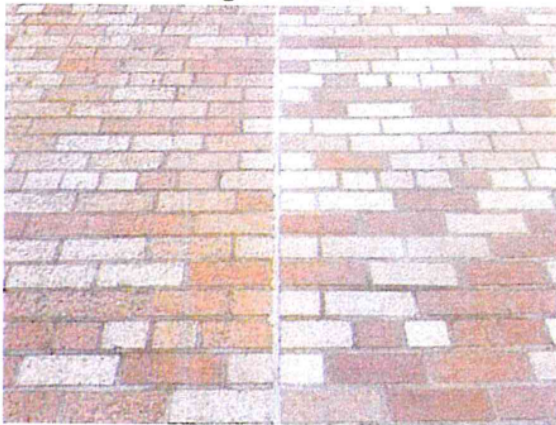
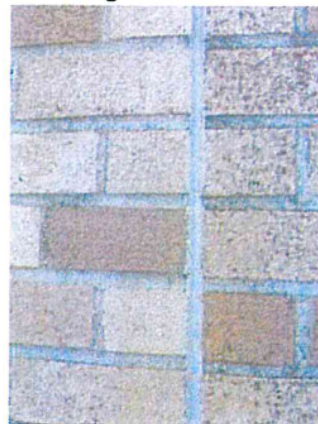
Figure D.1.2.1a

2. There are no expansion joints in the brick except where the addition ties into the original building.
  - (1) The brick expansion joint sealant between the original building and the addition is in good condition. We anticipate that sealants will need to be replaced within five years.

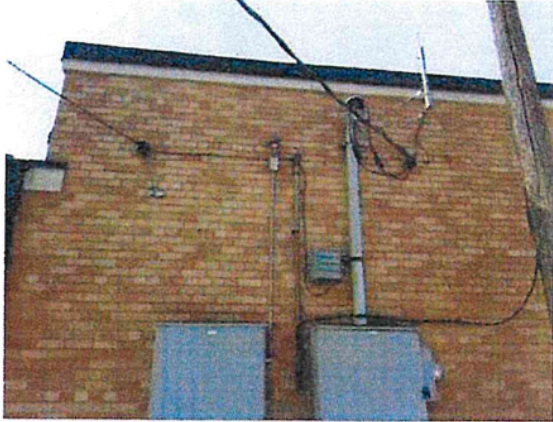
Figure D.1.3

3. The brick wall above the electrical service is stained. This is a cosmetic issue.
4. The infill walls clad in vinyl siding are in good condition.
5. The piping and conduit penetrations through the exterior wall are in generally good condition. We anticipate that sealants will need to be replaced within five years.

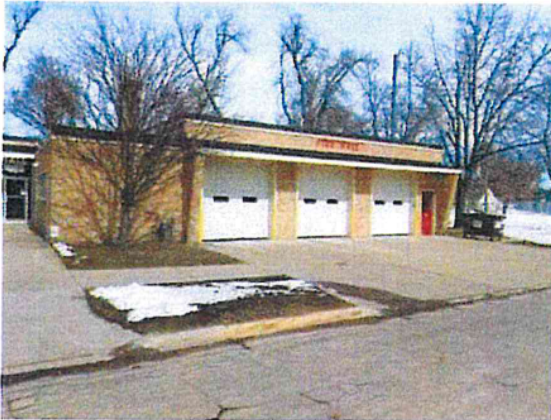
Figure D.2.1

2. Windows and Doors
  1. The apparatus doors are in good condition.
    - (1) The weatherstripping at the apparatus doors is in poor condition and should be replaced.

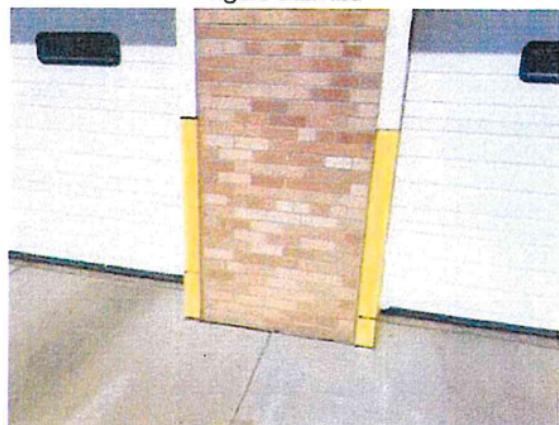
Figure D.2.1.2a

- (2) The steel angles at the apparatus door jambs are scraped and beginning to show signs of rust.
    - (3) The limestone surround at the west side of the center apparatus door is severely cracked and should be repaired to prevent further degradation.
