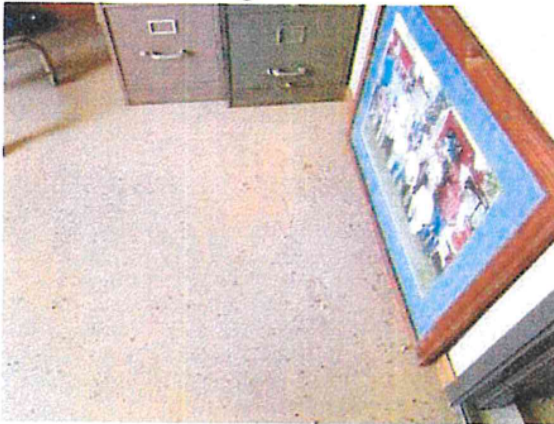
Figure E.1.1

1. Flooring
  1. The epoxy flooring in the office is in average condition with bleed-through from imperfections in the concrete slab-on-grade.
2. Walls
  1. The cement block walls in the Apparatus Bay are in generally good condition.
    - (1) There is vertical cracking in the non-bearing wall where the roof drain runs down the exterior wall.
    - (2) There is significant horizontal cracking where the ceiling joists pass through the wall separating the City Hall storage room from the Apparatus Bay. This is caused by normal building movement like the deflection of the roof structure under heavy snow loads.
  2. The gypsum board walls in the office are in good condition.
3. Doors and Windows
  1. The man door between the apparatus bays and the office is in good condition.
    - (1) The smoke seals are in good condition.

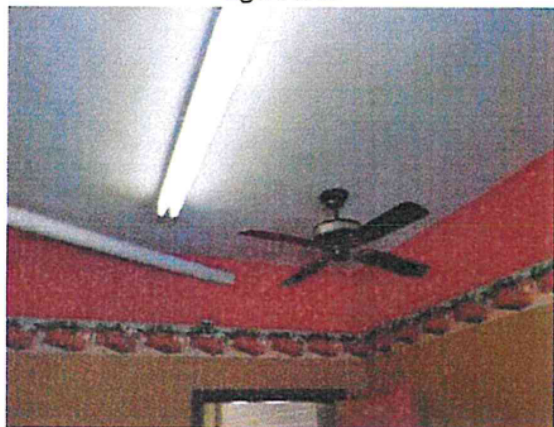
Figure E.4.1

2. The man door between the apparatus bays and the City Hall lobby is in good condition.
4. Ceilings
  1. The gypsum board ceiling in the Office is in good condition.

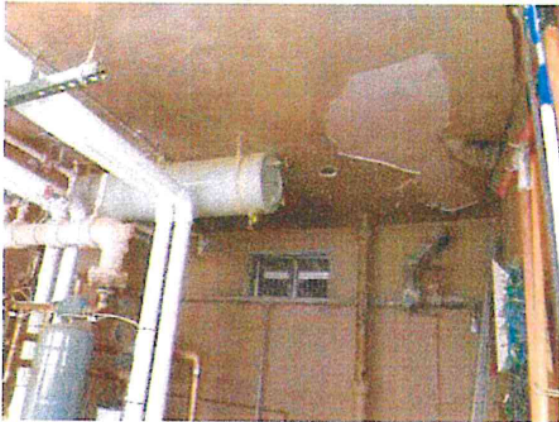
Figure E.4.2

2. The ceiling in the Boiler Room is in poor condition with portions of plaster loose around the roof drain.
5. Casework
  1. The wall cabinets in the Office are beyond their expected service life but are in good condition.

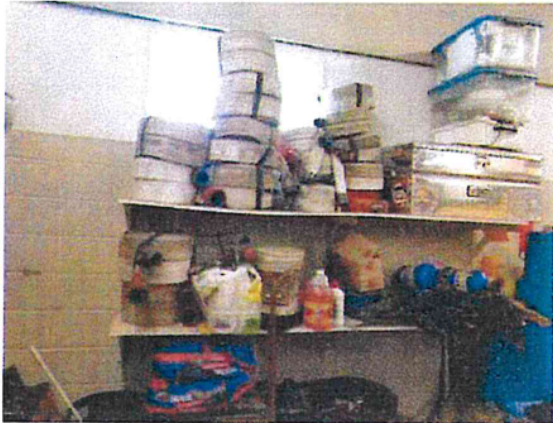
Figure E.5.4

2. The work counter in the Office is in good condition.
  3. The enclosed cabinets in the Apparatus Bay are in average condition.
  4. The open shelving in the Apparatus Bay is in poor condition with too much weight bending the shelves.

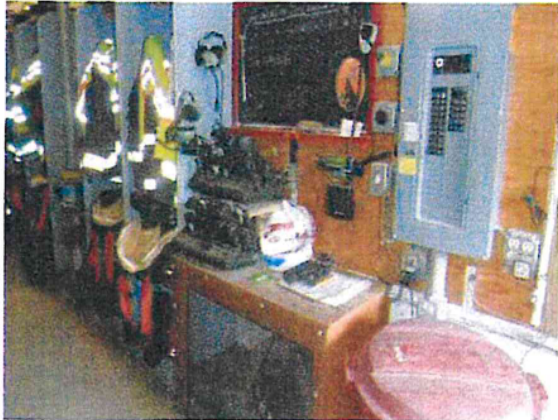
Figure E.5.6

5. The turnout gear lockers are in good condition.
  6. The counter and shelves at the radio storage area are in poor condition.
6. Equipment
  1. The ceiling fan in the office is in good condition.

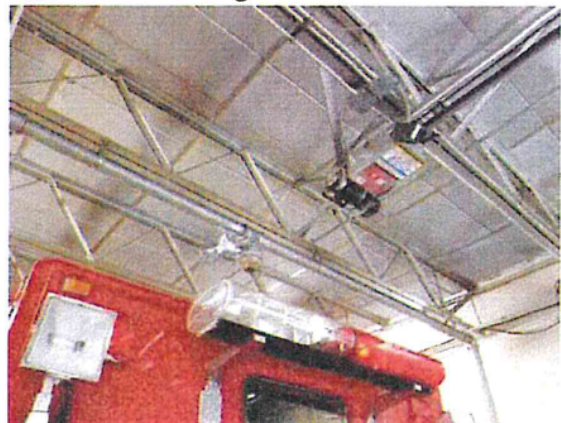
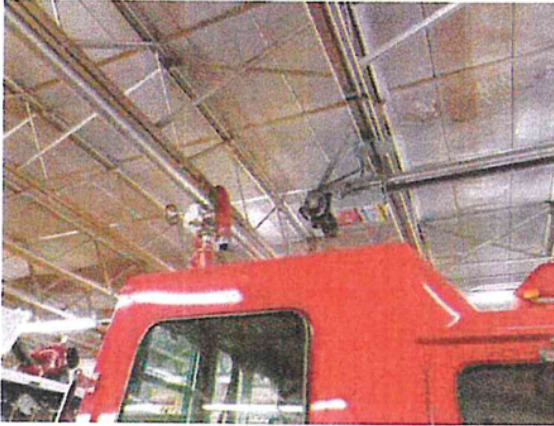
2. The Pepsi machine appears to be in good condition.
  3. The refrigerator in the Apparatus Bay is in poor condition.
  4. The drawbar-type overhead door openers are in good condition.

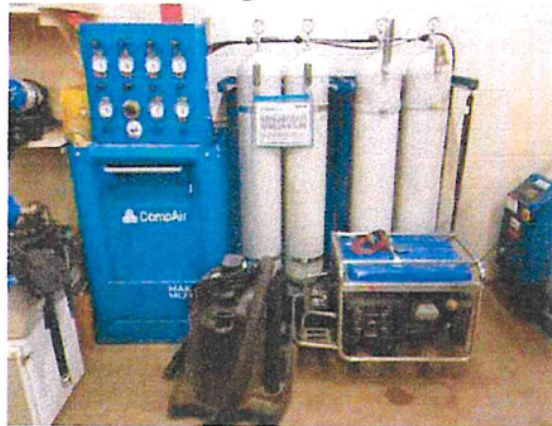
Figure E.6.5

5. The Mako SCBA cascade and fill station is in good condition.
  6. The Bauer SCBA compressor is in good condition and has an exterior air intake.

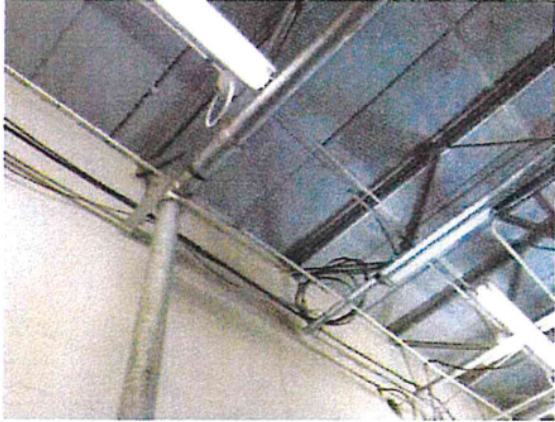
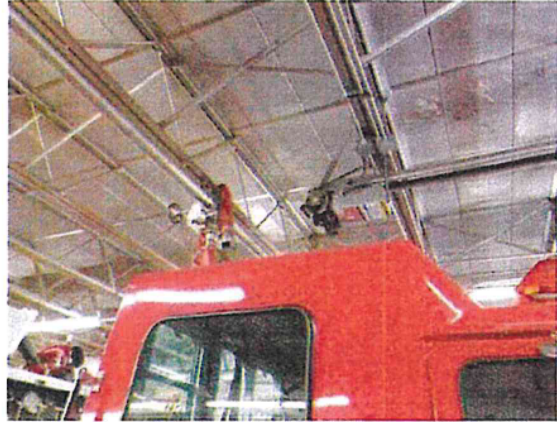
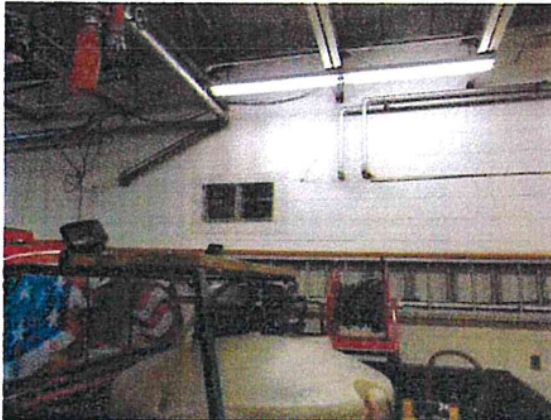
1. Domestic Water
  1. The cold water pipe crosses the apparatus bay above the trucks for tank-fill then enters the boiler room.
  2. A 34 kBTU 40-gallon gas fired water heater is installed in the Boiler Room
2. Sanitary Sewer
  1. The sanitary sewer system was not observed.
3. Compressed Air
  1. A 60-gallon air compressor is located in the boiler room and is in good condition.
