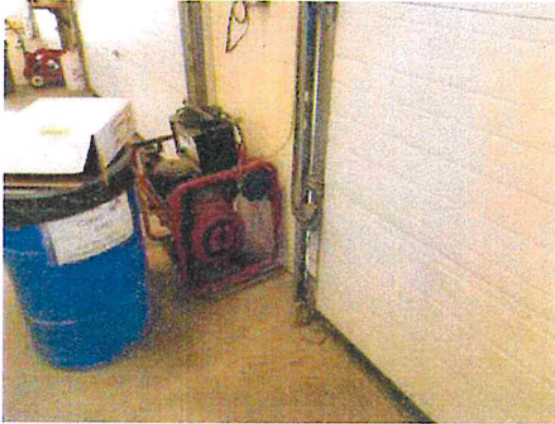
Figure Q.2

1. There is no fire suppression system or fire alarm system.
2. The overhead doors do not meet the provisions of UL325 because they do not have a photoeye within 6" of the floor.

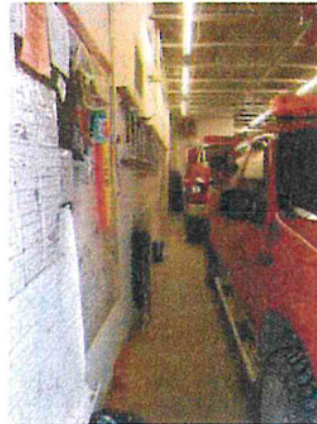
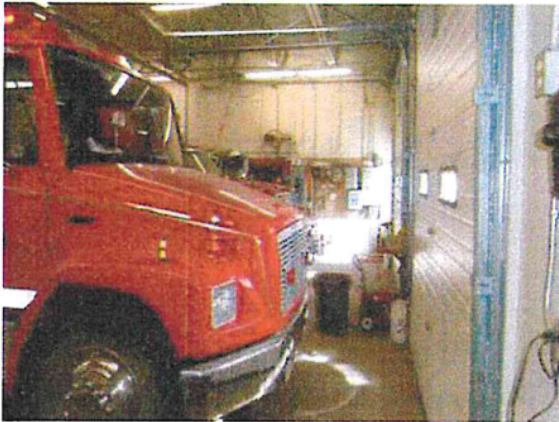
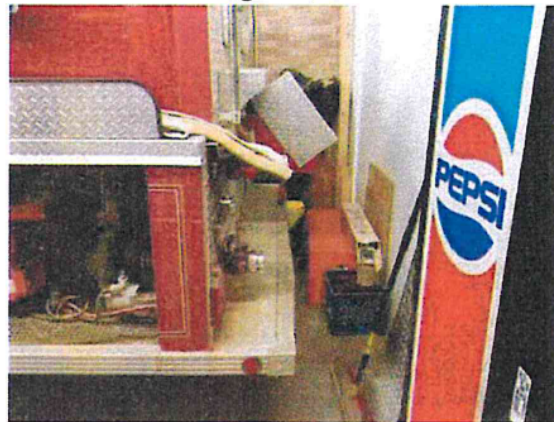
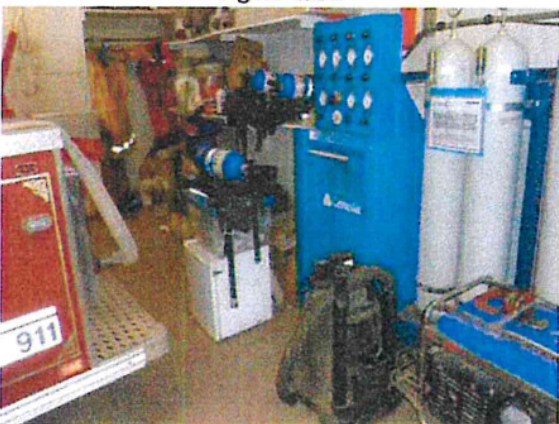
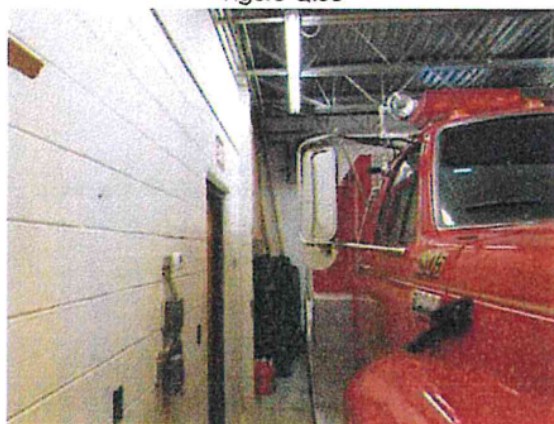
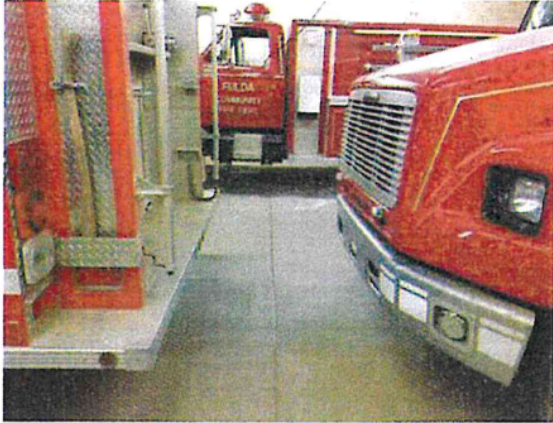
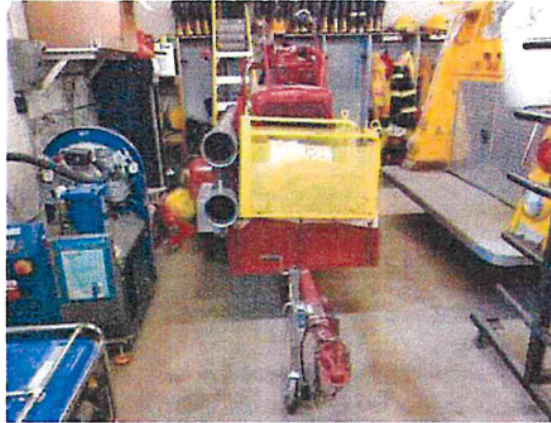
3. There is insufficient space to fit fire apparatus comfortably within the building. The apparatus is parked very close to the side walls, very close to the rear walls, and very close to each other. This proximity increases the risk that a firefighter will be injured by moving apparatus, whether it is backing into the station or whether it is responding while firefighters are getting onto the rig.

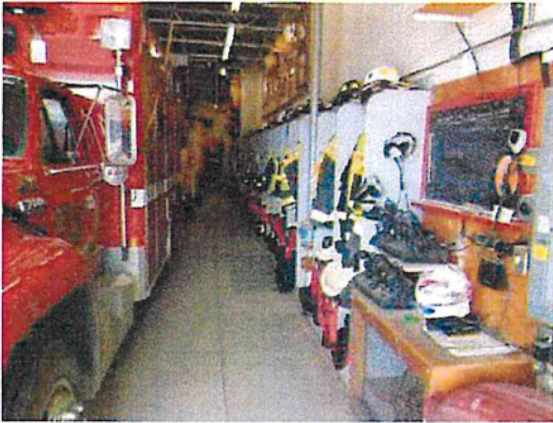
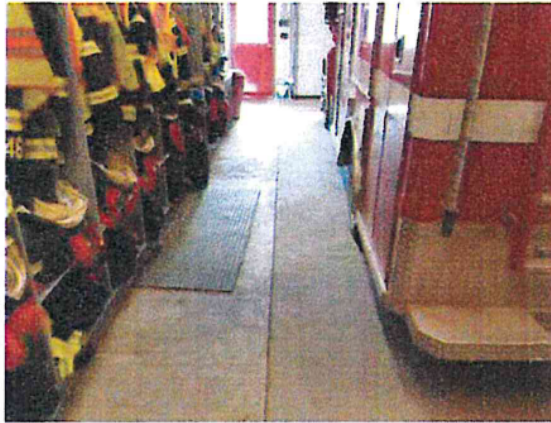
4. Turnout gear is located directly adjacent to apparatus, increasing the risk that firefighters donning their gear could be injured by moving apparatus.

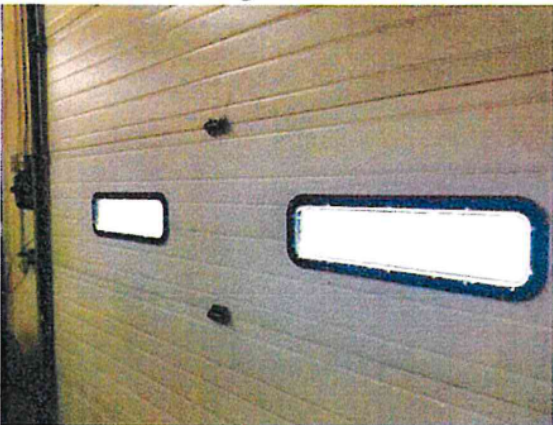
Figure Q.5

5. There is insufficient glass in the apparatus doors to be able to see what is directly outside the doors before opening them.
6. All vehicles must be backed into the station, which increases the risk that a firefighter could be injured by backing apparatus.

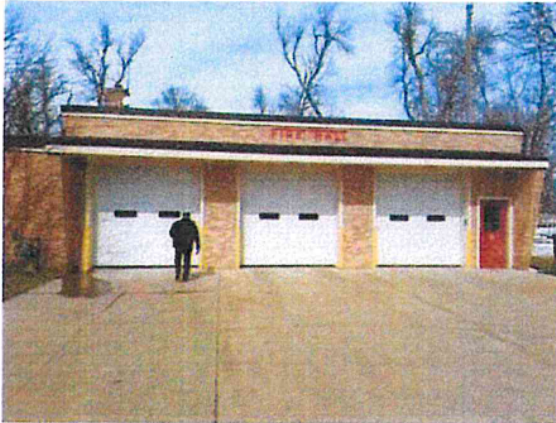
Figure Q.7

7. There is no safe path between firefighter parking and the entry door that does not pass directly alongside or in front of responding apparatus.

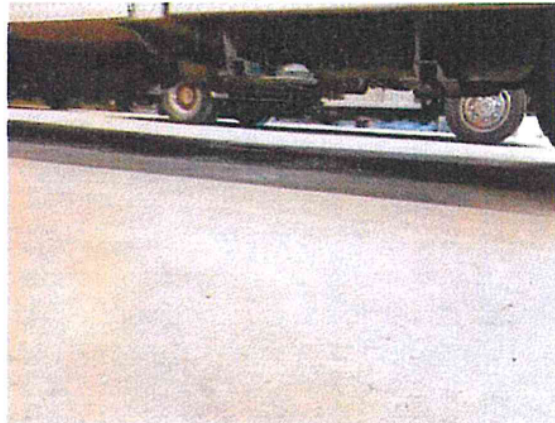
Figure Q.8

8. There is only one floor drain in the apparatus bays. This creates slip and fall hazards after returning from calls on a rainy day.
9. The Office is raised one step above the apparatus bay level, creating a trip hazard.

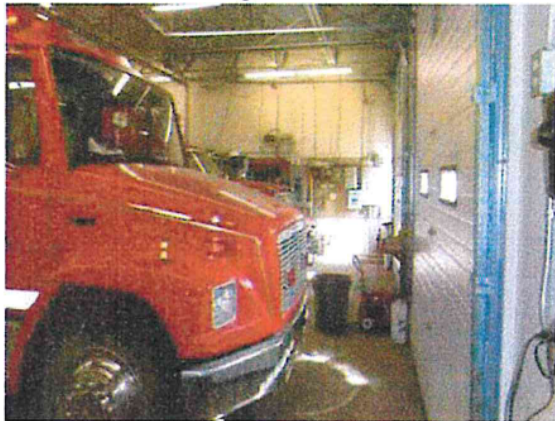
Figure Q.11

11. The main electrical equipment is located directly adjacent to the apparatus where it could get wet while apparatus are washed.
12. There is no dedicated space for turnout gear lockers that can segregate them from the remainder of the building. This is a violation of NFPA 1937 and forces the firefighters to wear gear that has been exposed to diesel exhaust.

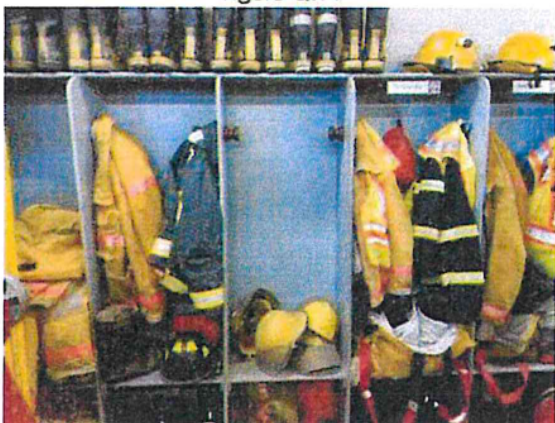
Figure Q.14

13. The nearest turnout gear washing facilities are in Slayton, reducing the likelihood that the gear will be washed as frequently as it should be.
14. The turnout lockers do not promote passive airflow in and around the gear, requiring a fan to push air through vents in the bottom of each locker.

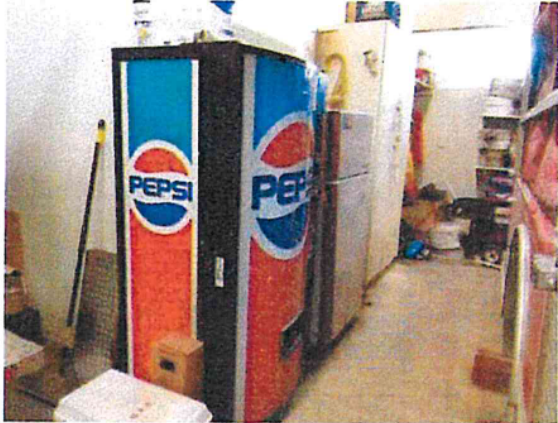
Figure Q.20.2

2. There is a Pepsi machine and a refrigerator in the apparatus bay where the contents can be easily contaminated.
  3. The Boiler Room is open to the apparatus bays, creating significant cross contamination issues between clean and dirty spaces.

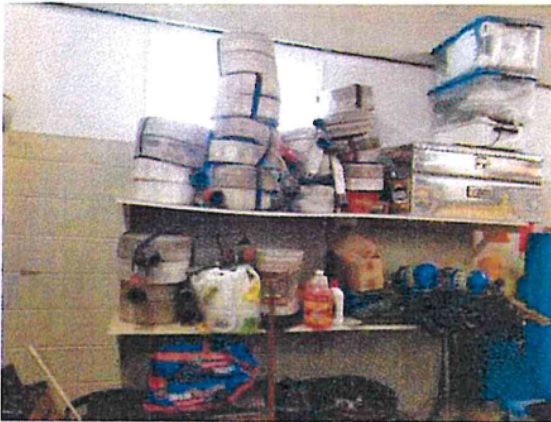
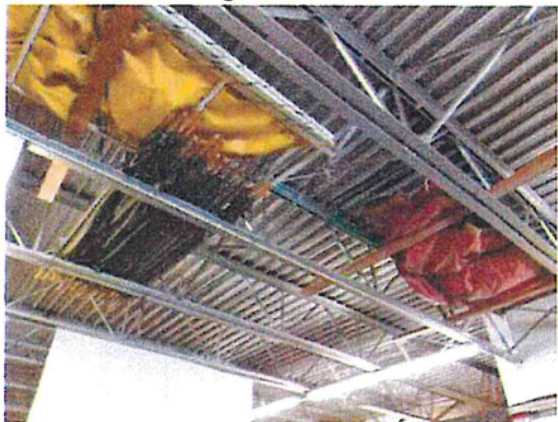
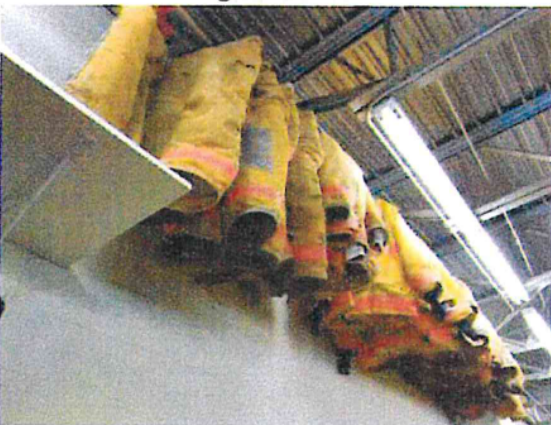
4. There is insufficient space for storage of hoses, spare SCBA units, extra turnout gear, hoses, paper products, emergency cots, etc. These items are then stored in the apparatus bay where they are exposed to fireground toxins and diesel particulates.

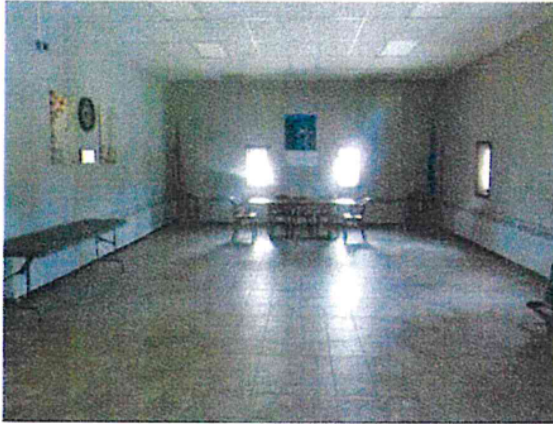
Figure R.1

1. There is no dedicated educational and meeting space for the fire department. The meeting space in the City Hall is frequently in use during Department meeting nights. This may lead to problems complying with training requirements of NFPA 1720.

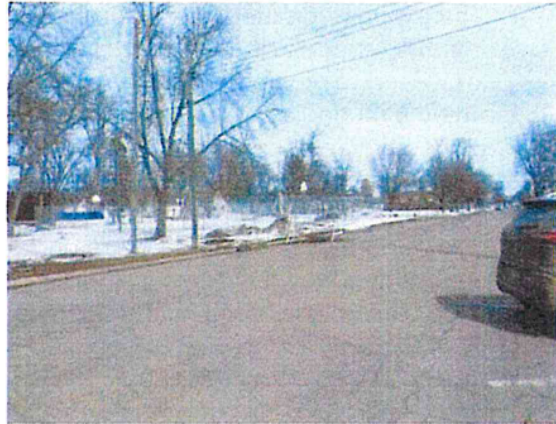
Figure R.2

2. There is no dedicated parking for responding firefighters, causing them to have to run from a half a block away if an event is happening at the library or the City Hall.

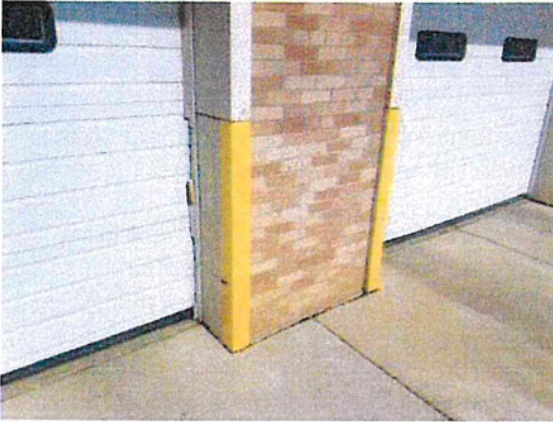
Figure R.3

3. There are no bollards protecting the building from backing apparatus.
4. Due to limited hose bib locations, washing apparatus is difficult to do.
5. The apparatus doors are 10' wide and 10' tall, which is smaller than the 14' x 14' door recommended for modern fire apparatus. This puts a severe restraint on the apparatus that can be purchased for the department.

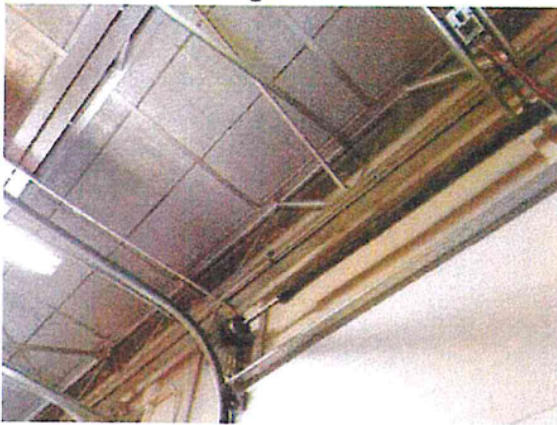
Figure R.6

6. The apparatus doors are not designed for heavy use with 100,000 cycle springs and 3" tracks, leading to more frequent failures.
7. The apparatus door controls are only located at the corner of the apparatus bay. There are no controls adjacent to the individual apparatus doors and there are no remote controls inside the cabs of the vehicles.

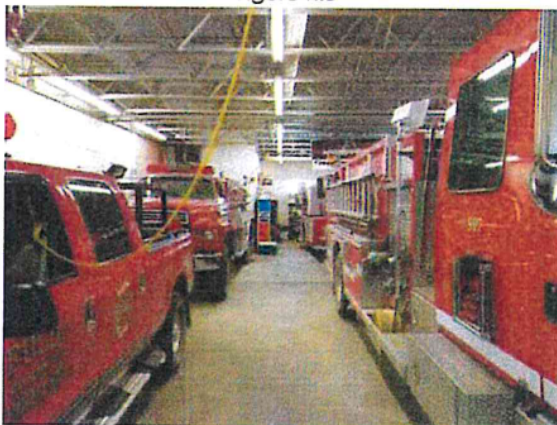
Figure R.8

8. There are not apparatus doors on both sides of the station but apparatus are double stacked in the bays. This means that if the vehicle in front breaks down the apparatus behind it cannot respond either.

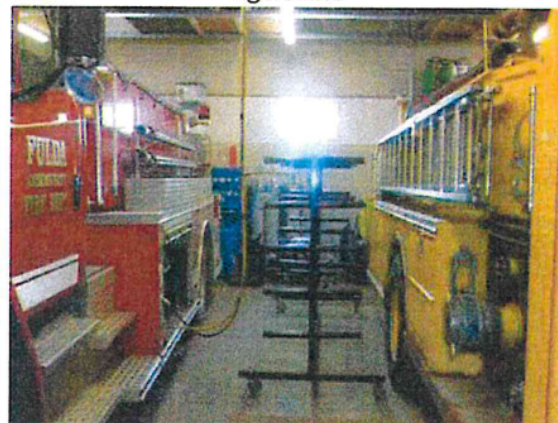
Figure R.13

13. There is no space for hose cleaning and hose drying in the current space except squeezed between rigs where it must be moved out of the way in an emergency.

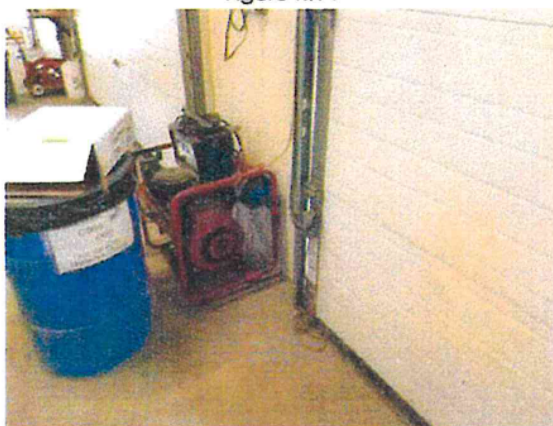
Figure R.14

14. There is no backup generator for the building, which may cause the radio equipment in the trucks to drain the batteries in the event of power failure.
