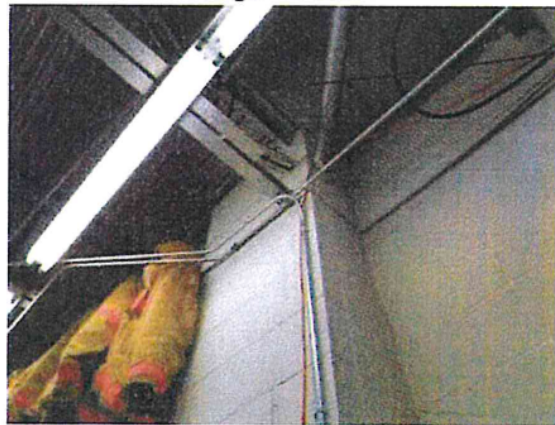
Figure E.2.1.1

1. Flooring
  1. The epoxy flooring in the office is in average condition with bleed-through from imperfections in the concrete slab-on-grade.
2. Walls
  1. The cement block walls in the Apparatus Bay are in generally good condition.
    - (1) There is vertical cracking in the non-bearing wall where the roof drain runs down the exterior wall.
    - (2) There is significant horizontal cracking where the ceiling joists pass through the wall separating the City Hall storage room from the Apparatus Bay. This is caused by normal building movement like the deflection of the roof structure under heavy snow loads.
  2. The gypsum board walls in the office are in good condition.
3. Doors and Windows
  1. The man door between the apparatus bays and the office is in good condition.
    - (1) The smoke seals are in good condition.

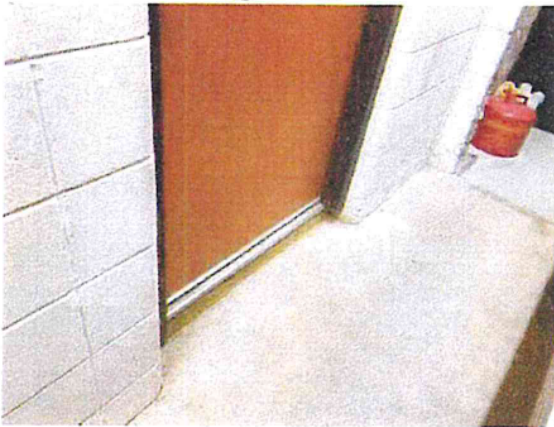
Figure E.3.2

2. The man door between the apparatus bays and the City Hall lobby is in good condition.
4. Ceilings
  1. The gypsum board ceiling in the Office is in good condition.

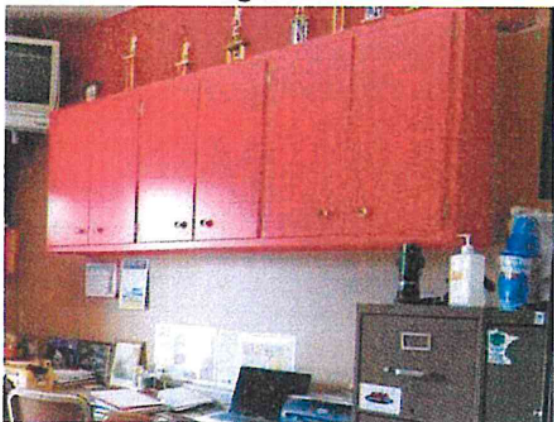
Figure E.5.1

2. The ceiling in the Boiler Room is in poor condition with portions of plaster loose around the roof drain.
5. Casework
  1. The wall cabinets in the Office are beyond their expected service life but are in good condition.

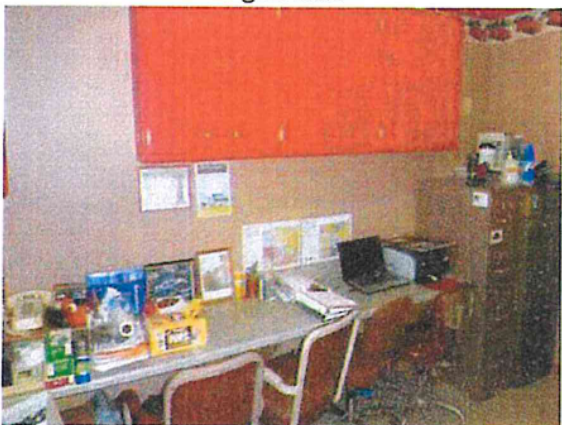
Figure E.5.2

2. The work counter in the Office is in good condition.
  3. The enclosed cabinets in the Apparatus Bay are in average condition.
  4. The open shelving in the Apparatus Bay is in poor condition with too much weight bending the shelves.

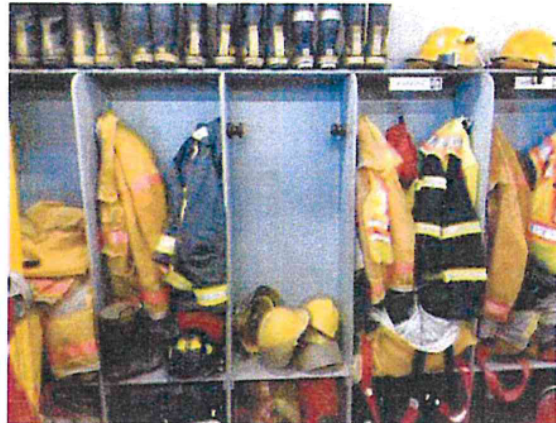
Figure E.5.5

5. The turnout gear lockers are in good condition.
  6. The counter and shelves at the radio storage area are in poor condition.
6. Equipment
  1. The ceiling fan in the office is in good condition.

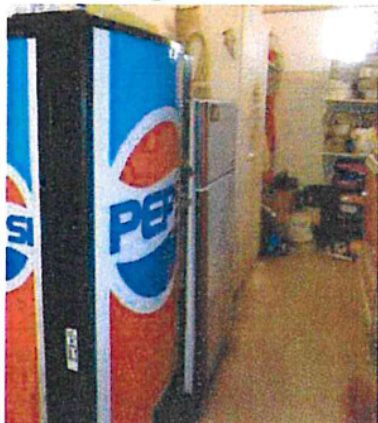
Figure E.6.2

2. The Pepsi machine appears to be in good condition.
  3. The refrigerator in the Apparatus Bay is in poor condition.
  4. The drawbar-type overhead door openers are in good condition.

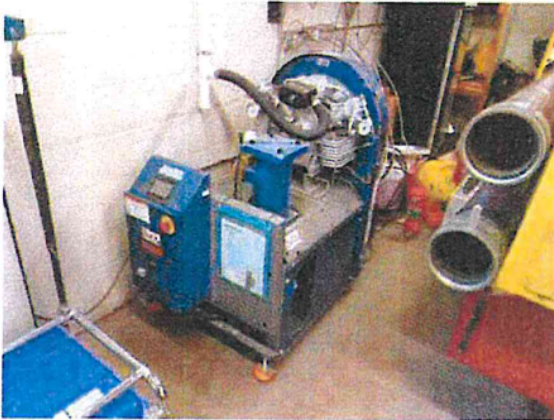
Figure E.6.6

5. The Mako SCBA cascade and fill station is in good condition.
  6. The Bauer SCBA compressor is in good condition and has an exterior air intake.

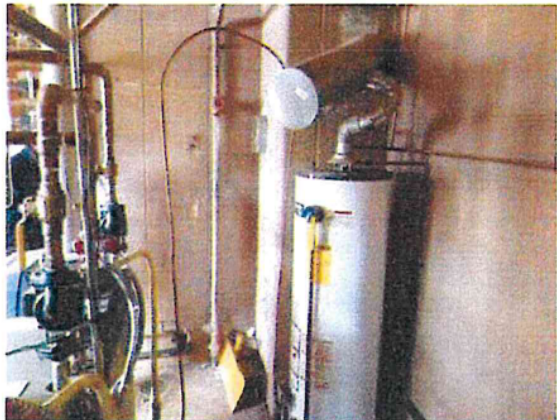
Figure H.1.2a

1. Domestic Water
  1. The cold water pipe crosses the apparatus bay above the trucks for tank-fill then enters the boiler room.
  2. A 34 kBTU 40-gallon gas fired water heater is installed in the Boiler Room
2. Sanitary Sewer
  1. The sanitary sewer system was not observed.
3. Compressed Air
  1. A 60-gallon air compressor is located in the boiler room and is in good condition.
